MID SOUND FISHERIES ENHANCEMENT GROUP

# Hawks Hole Creek (15.0347)

## Survey Report

Author: Danielle DeVoe, Project Manager  
December 2010 - January 2011

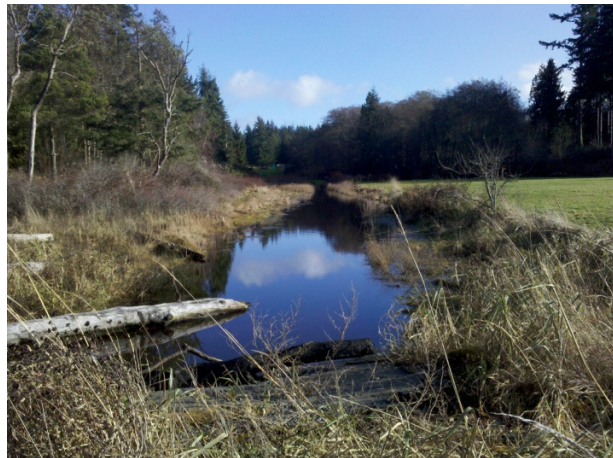
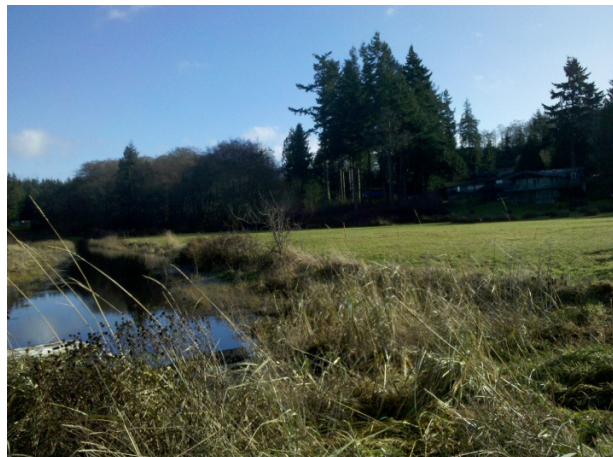
Salt marsh and tidal channel habitats filled in the lower 200 meters of stream during the 1960-70s represent an opportunity to reclaim lost habitat. The fill could be removed and the much needed estuarine habitat could be recreated. Floodplain conditions have been

rated *fair*, which corresponds to 25-50% of floodplain area altered or lost according to the habitat rating for Hawks Hole (WDFW; SSHEAR, 2000).

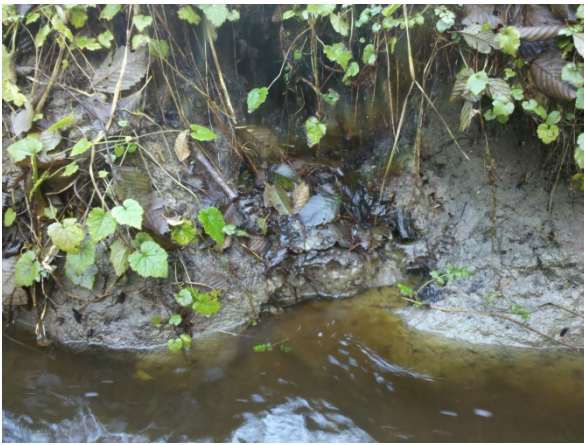
Large woody debris (LWD) is sparse from the mouth to just past Hood Canal Drive, and more frequent upstream to the pond.

(Above: Downstream of Hood Canal Dr.; soft, silt banks)

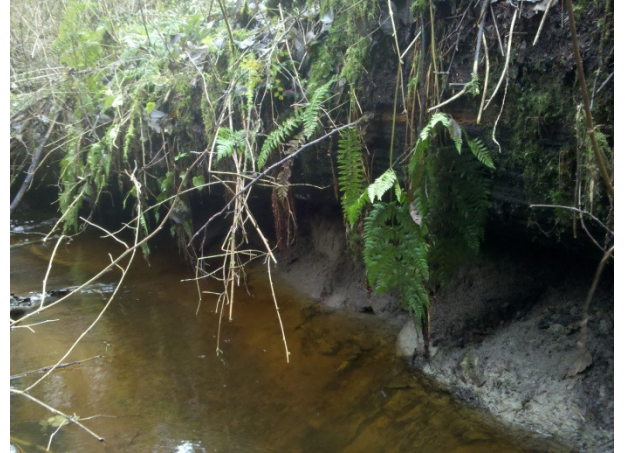
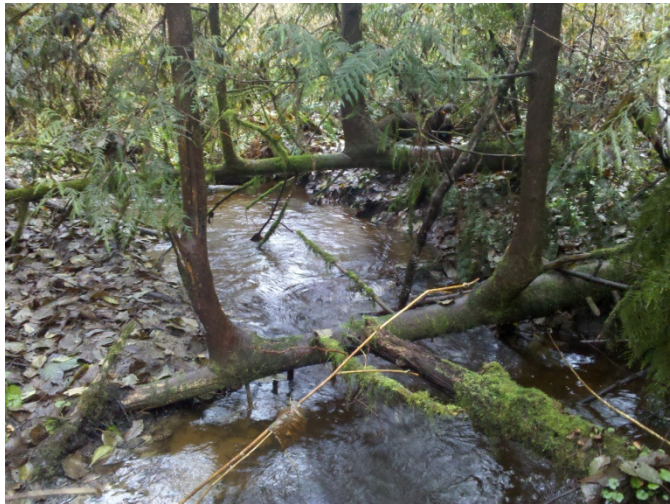
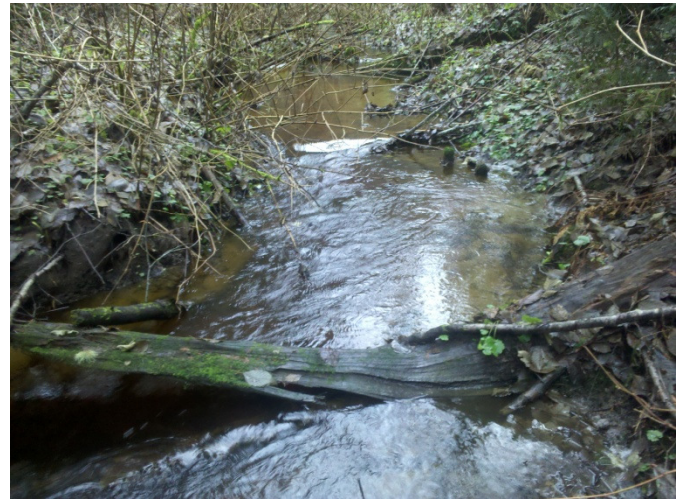
Upstream of the Hood Canal Drive culvert, the creek appears to be in a more natural state with a higher frequency of woody debris, primarily cedar. This woody debris creates more, and deeper, pool habitat, although no pool was measured equal to or great than 1 meter. (rated percent pools 18.3% = poor; few deep pools with little complexity) (Stream bank stability = fair; open flood plain upper half).

(Above: Upstream of Hood Canal Dr.; increase in LWD and habitat diversity)

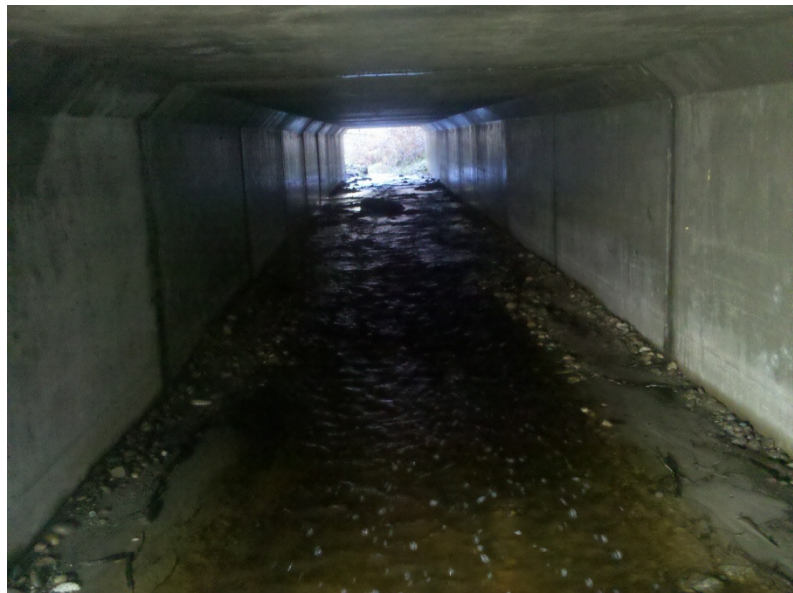
80011.1

The first culvert we encountered was under Hood Canal Drive. This culvert was not a barrier based on having substrate throughout the culvert and a width over 75% of the average streambed toe width.

(Above; Culvert under Hood Canal Dr.)

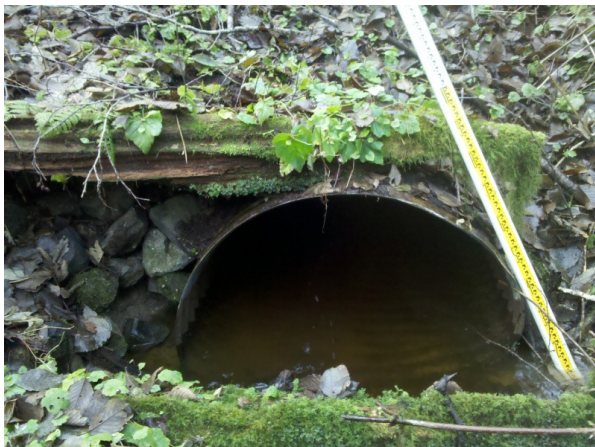
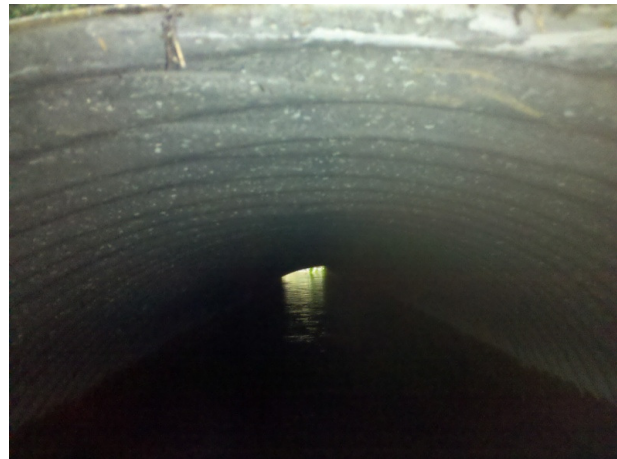
80021.1

The second, and final culvert that we encountered was under Greenway Trail. The culvert appears undersized for stream width and sagging in multiple locations; projected to fail but not an immediate threat. There is not streambed material throughout the entire length of the culvert and level B data was taken to determine barrier status. The culvert was determined to be a partial barrier with a passability value of 0.67 (0.33 barrier). Details of measurements recorded can be found in attached excel spread sheet.

Lastly, we recommend that the Greenway Trail culvert be replaced due to its small size in relation to stream width, but more so due to the fact that it is sagging and structurally unsound. Because the culvert only poses a 33% barrier, it is not as high of a priority, as far as salmon are concerned, as the above issues. Its prioritization is also relatively low on this list due to the fact that this is not a creek that would support salmon and it is very unlikely a salmon would reach the culvert.

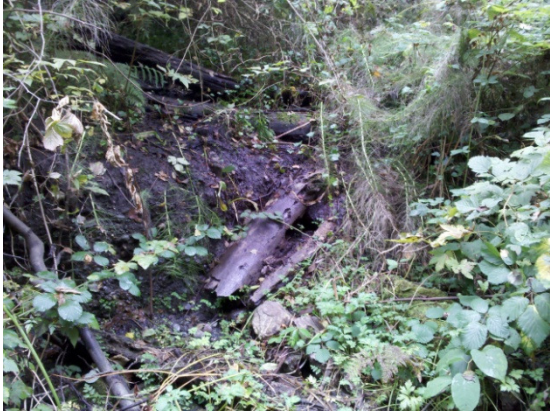
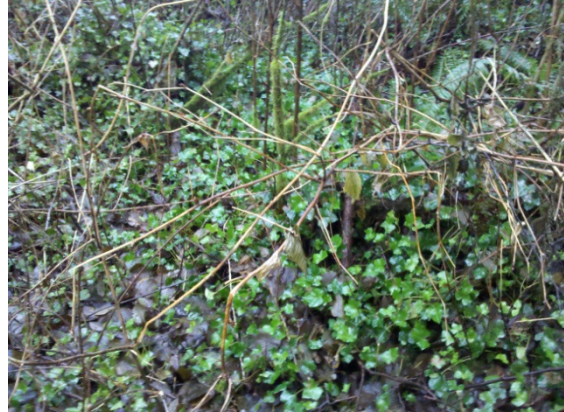
Thirdly, removal of invasive species is critical to maintaining the natural vegetation present. There are a few sites where English Ivy and/or Himalayan Blackberry (see pic; below) is present and quickly taking over the riparian area. At these sites, the ivy can be eradicated and the excellent stream buffer will remain native and functional (see data sheet for GPS locations).
