MID SOUND FISHERIES ENHANCEMENT GROUP

# Hawks Hole Creek (15.0347)

## Survey Report

Author: Danielle DeVoe, Project Manager  
December 2010 - January 2011

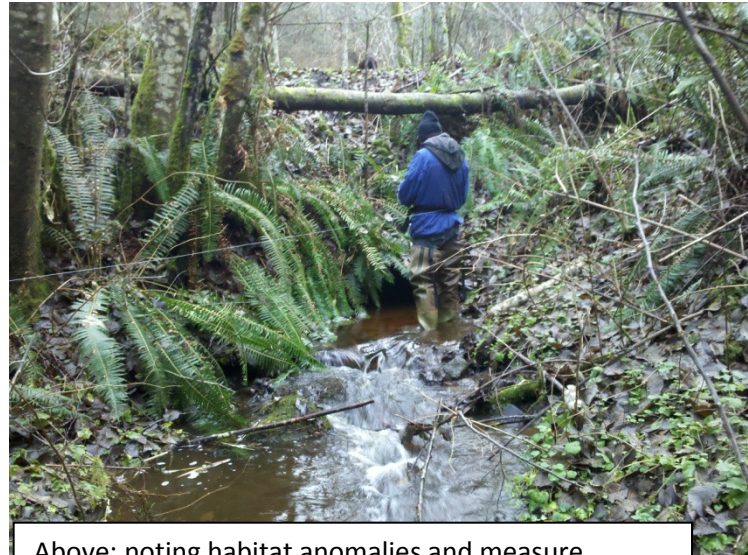
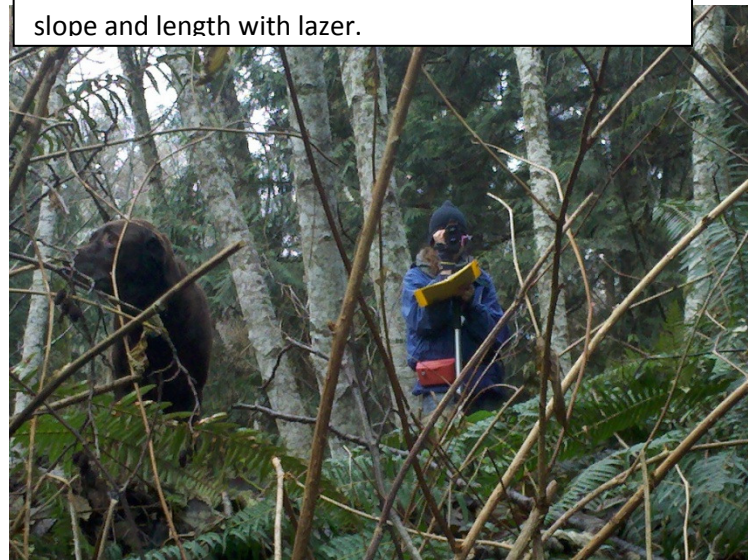
Above: noting habitat anomalies and measure meterage on hip chain. Below: measuring culvert slope and length with lazer.
